The Locomotive

THE HARTFORD STEAM BOILER
INSPECTION AND INSURANCE CO.

HARTFORD, CONN.
1912-1913.

Water Gage Glasses.

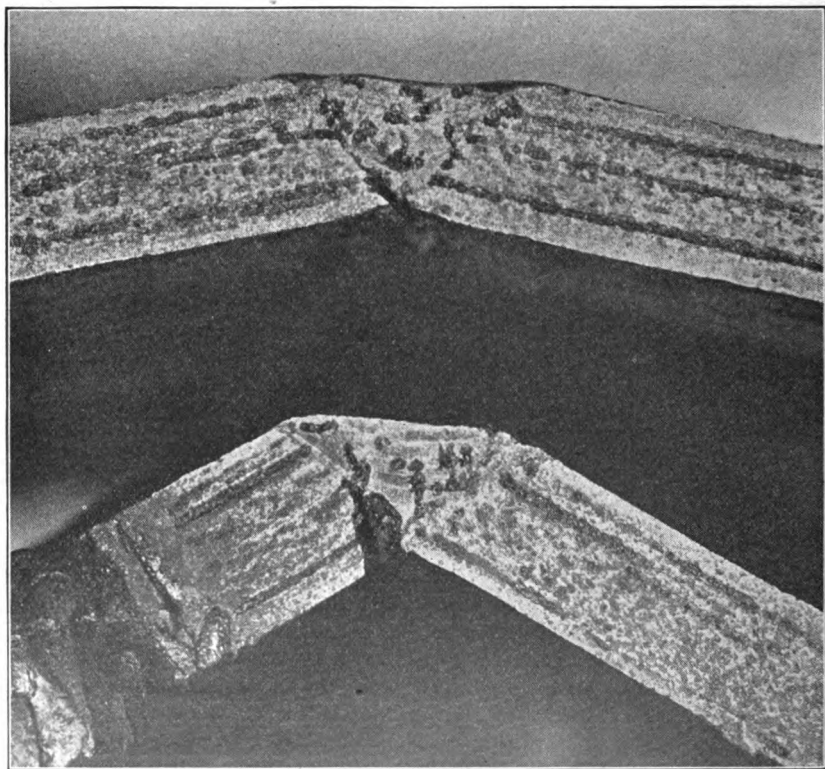
FIG. 1. (Upper.) ETCHED SECTION OF LONGITUDINAL SEAM.

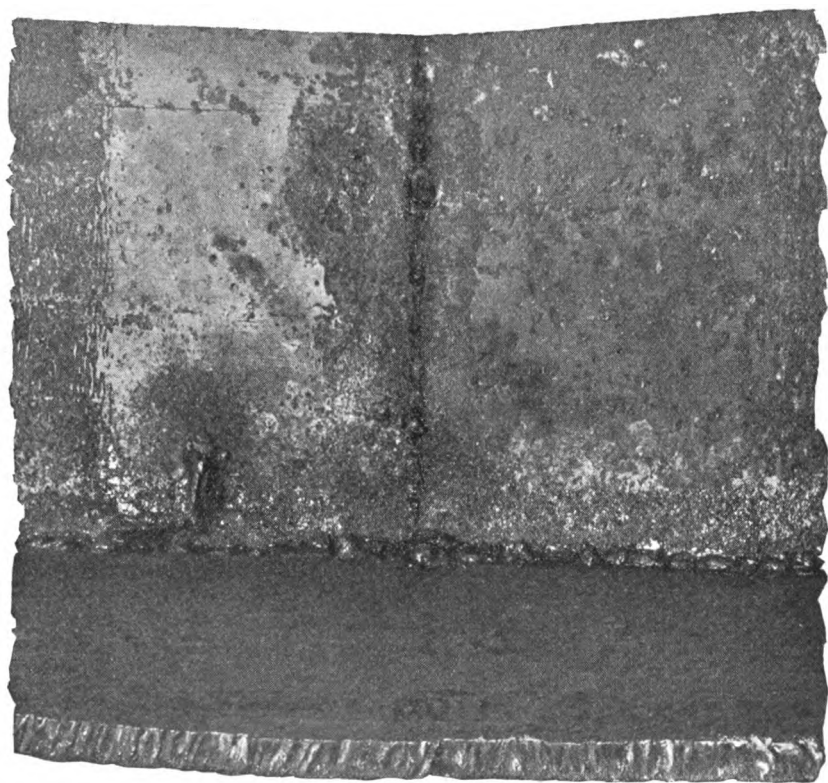
FIG. 3. WELDING OF HEAD TO SHELL. NOTE THE ROUGH CHARACTER OF THE WORK.

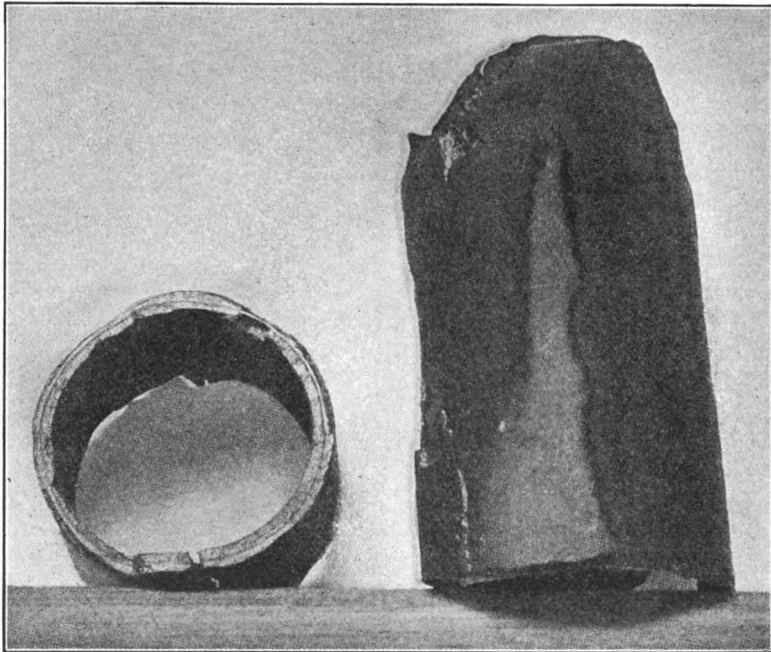
FIG. 1.

In the case in question, the original thickness of the tubes was .080 in., equal to No. 14 standard gauge (B. W. G.) in a section shown in Fig. 1, the thickness of the remaining metal is .012 in. on one side and on the opposite side the metal has entirely disappeared. The thickness of the oxide is .047 on the outer side and .065 on the inner side. The total maximum thickness of the oxide and the residue of metal is .124 in., which it may be observed is considerably greater than the original thickness of the metal, the difference being due to the expansion of iron and steel in the process of oxidation. Therefore 80 to 100 per cent. of the metal has been converted into oxide, and 15 to 20 per cent. remains in its original condition. Fig. 2 shows the irregularity of the oxidized surface, probably due to the current of steam. Fig. 3 shows the black oxidized surface of the metal after the removal of the principal coating of oxide.

In the present case the boiler was heavily worked, and consequently the temperature in the downtake was high. (This refers of course to a Lancashire or Cornish boiler, where the gases pass *down* to the return flues. Editor.) Also only about one-third of the total amount of steam produced was passed through the superheater. By each of these conditions the temperature of the steam as delivered from the superheater would be increased, and in the combined result the temperature of the steam has been raised beyond the point of safety, as shown by the chemical change produced.

The case is a most instructive one, and imperatively shows that superheaters should not be made so large as to involve any risk of causing excessive temperature in the steam, which obviously is attended with grave danger in direct regard to superheater, pipes and engine; also indirectly in regard to the boiler.
